CHINIAGO INC. JUNE 1981

LELEIWI POINT AND KALAPANA, HAWAII: ARCHAEOLOGICAL RECONNAISSANCES

U. S. ARMY ENGINEER DISTRICT, HONOLULU Contract No. DACW84-81-M-0375

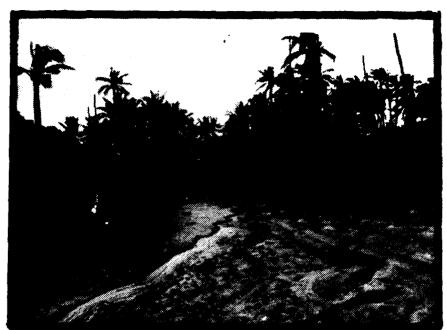
Kikoa Heiau [Figures 3 and 4] is completely overgrown with dense vegetation and appears to have suffered somewhat from seismic activity, both factors making observations difficult. The walls are collapsing, and a shallow pool resulting from the recent subsidence approaches to within five feet of the structure. The description provided by Kekahuna and Kelsey is more accurate than that of Hudson, and the discrepancy between the two is so great as to suggest that Hudson was describing another site altogether.

Figure 3. Plan of Kikoa Heiau. [after Kekahuna and Kelsey (1952)]

Figure 4. Location of Kikoa Helau, looking West. [behind palm grove at center of picture]

The vague platforms which Hudson mentioned as being inland of the heiau could not be located.

Kikoa Heiau, Kikoa Fishpond and Star of the Sea Painted Church are all eligible to the National Register of Historic Places. The heiau and the fishpond are eligible on the basis of the potential they have for providing information concerning the prehistory of Puna District. According to historical architect Spencer Leineweber of Spencer Ltd. [personal communication], the church is eligible primarily because of its combination of architectural and artistic values. It is somewhat tenuously eligible because it has a link with Father Damien as the successor to his church at Kupaahu.

It is therefore strongly recommended that Kalapana be removed from consideration as an alternative location for a small boat harbor.

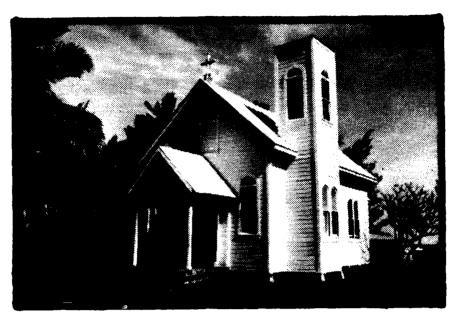
The Star of the Sea Church, which is also referred to as Kalapana Painted Church and Puna Painted Church [Figure 5] was constructed in 1929 by Father Evarist Gielen, who in 1931 and

Figure 5. The Painted Church at Kalapana. [Nancy Bannick photo]
